An Antenna Autopsy

By Eugene Morgan (WB7RLX)

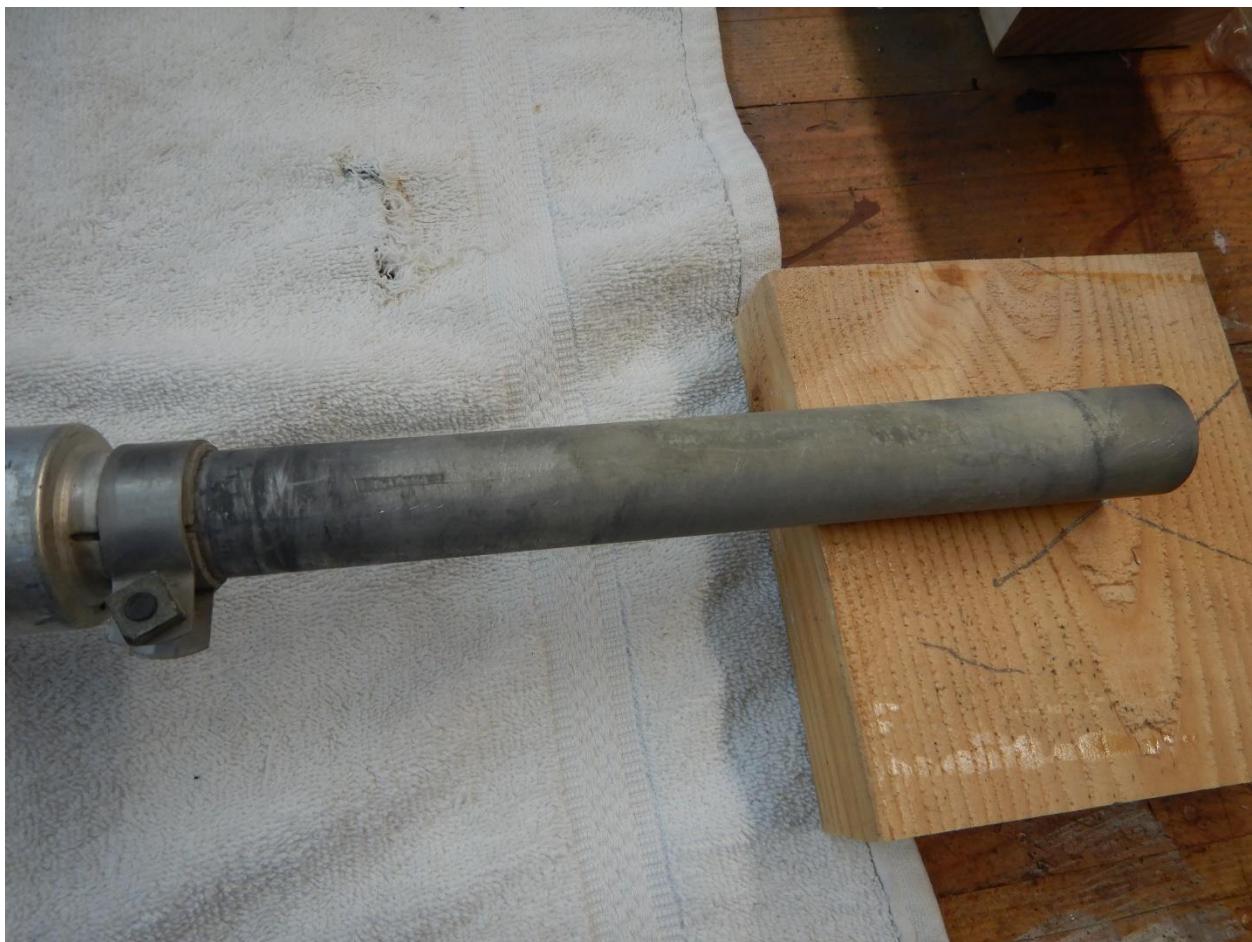
Findings: I began by separating the antenna at each of its joints. At each joint where one element slips into the other I found extensive corrosion. Of particular note is at the first joint at the base of the antenna. For extra strength hustler used what I believe is a stainless steel pipe that extends through the base and at least a foot into the first aluminum element. There the corrosion was at its worse. I suspect the issue is what we call galvanic action. Although the picture below is not of the specific corrosion I was referring to it is representative of the corrosion I found on virtually every connection point on the antenna. Corrosion inhibits the flow of power throughout the antenna and can waste valuable energy. In the worst case it can inhibit the flow of energy altogether. This kind of corrosion is why we sometimes see fluctuation in SWR and intermittent performance. This kind of corrosion can be minimized by using an anti-oxidizing compound like Penetrox or Jet-Lub and where possible sealing the connection with self-vulcanizing tape in an effort to keep water out of the connection.

Figure 1: Extreme Corrosion at element connection points

I used a metal tubing cleaner on the end of a drill to clean out the inside of each element and remove corrosion. I use brass wool to clean and polish the outside of each element. The goal was to ensure that all corrosion had been removed from each connection point. To ensure a long lasting solid electrical connection between each antenna section I applied a liberal coating of Penetrox and installed new stainless steel hose clamps.

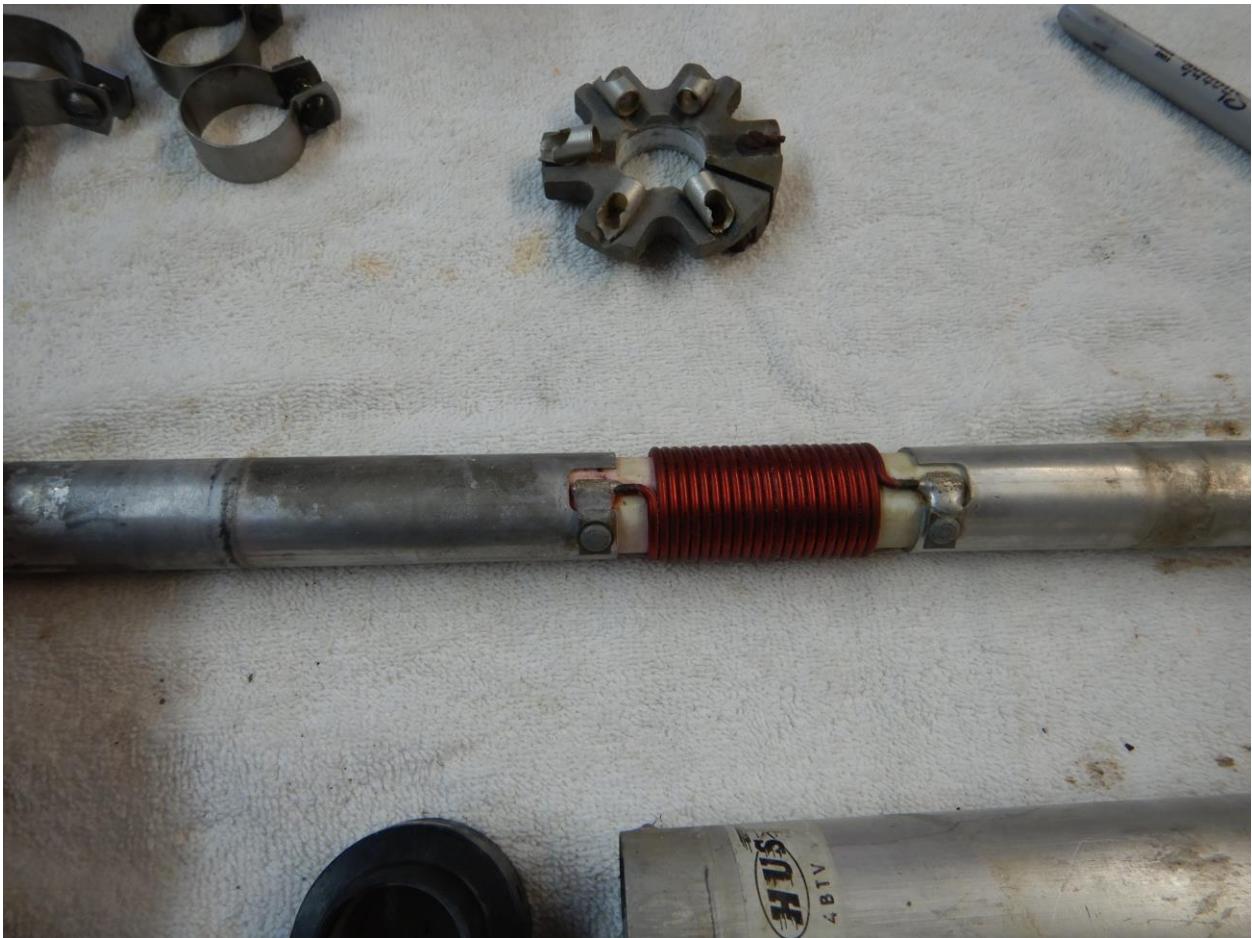
Figure 2: Examples of more corrosion found inside the traps

I carefully disabled each trap, cleaned them with a damp cloth and compressed air. I then checked each for resistance. They all checked out healthy. I then reassemble using Penetrox and the new plastic trap caps. I also made sure to set each metal trap cover back to the factory settings. One of the tuning steps I was not aware of with the BTV is the ability to adjust the metal trap covers.

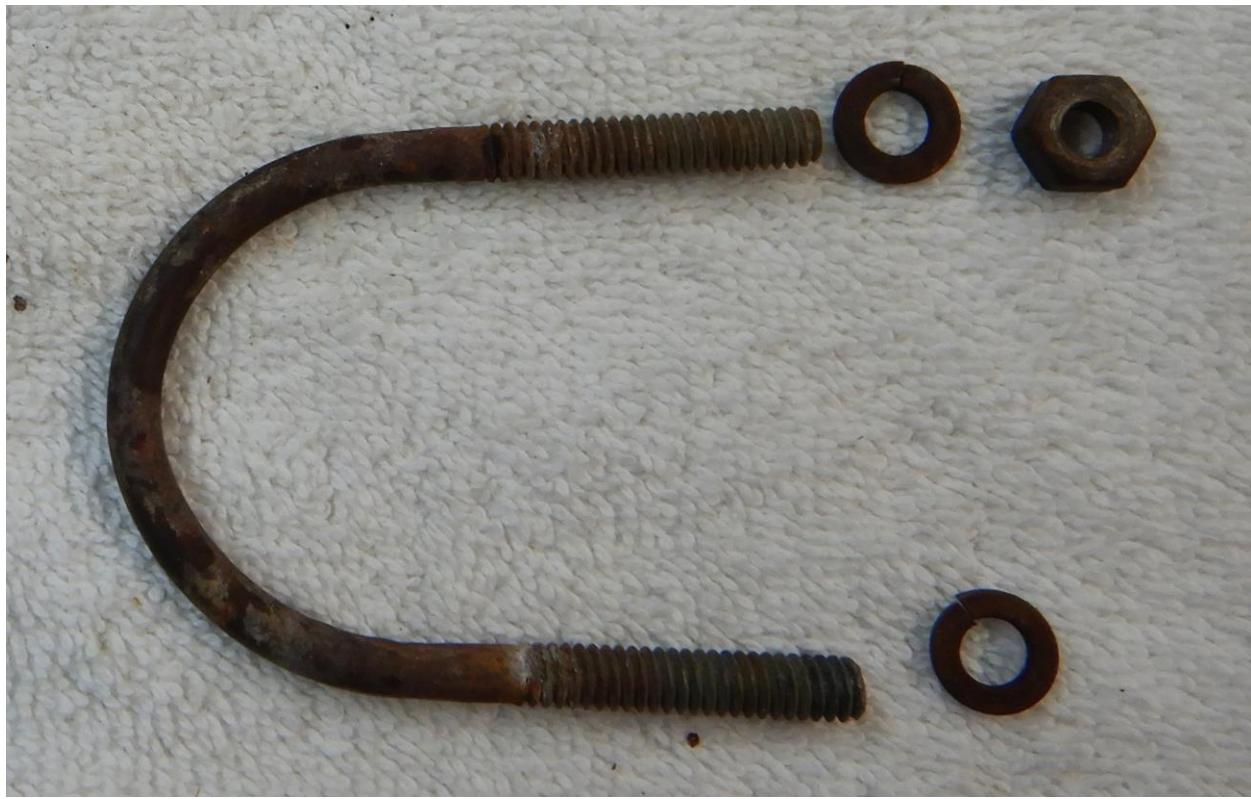
The second issue I found was the use of non-stainless steel components. In most cases this is the fault of the manufacturer more than the builder. In the case of the Hustler antenna there were several examples of this. The screws had so badly rusted that it was not possible to unscrew the fasteners and instead a chisel had to be used to remove the screws.

Figure 3: Rusted U Bolts. I hate to think how many of these I've seen twist off because the bolts were so baldy rusted

I replaced all non-stainless steel nuts and bolts with a proper stainless steel equivalent. To each bolt I put a dab of anti-seize compound before assembly. I also replace all the element clamps with new stainless steel hose clamps.

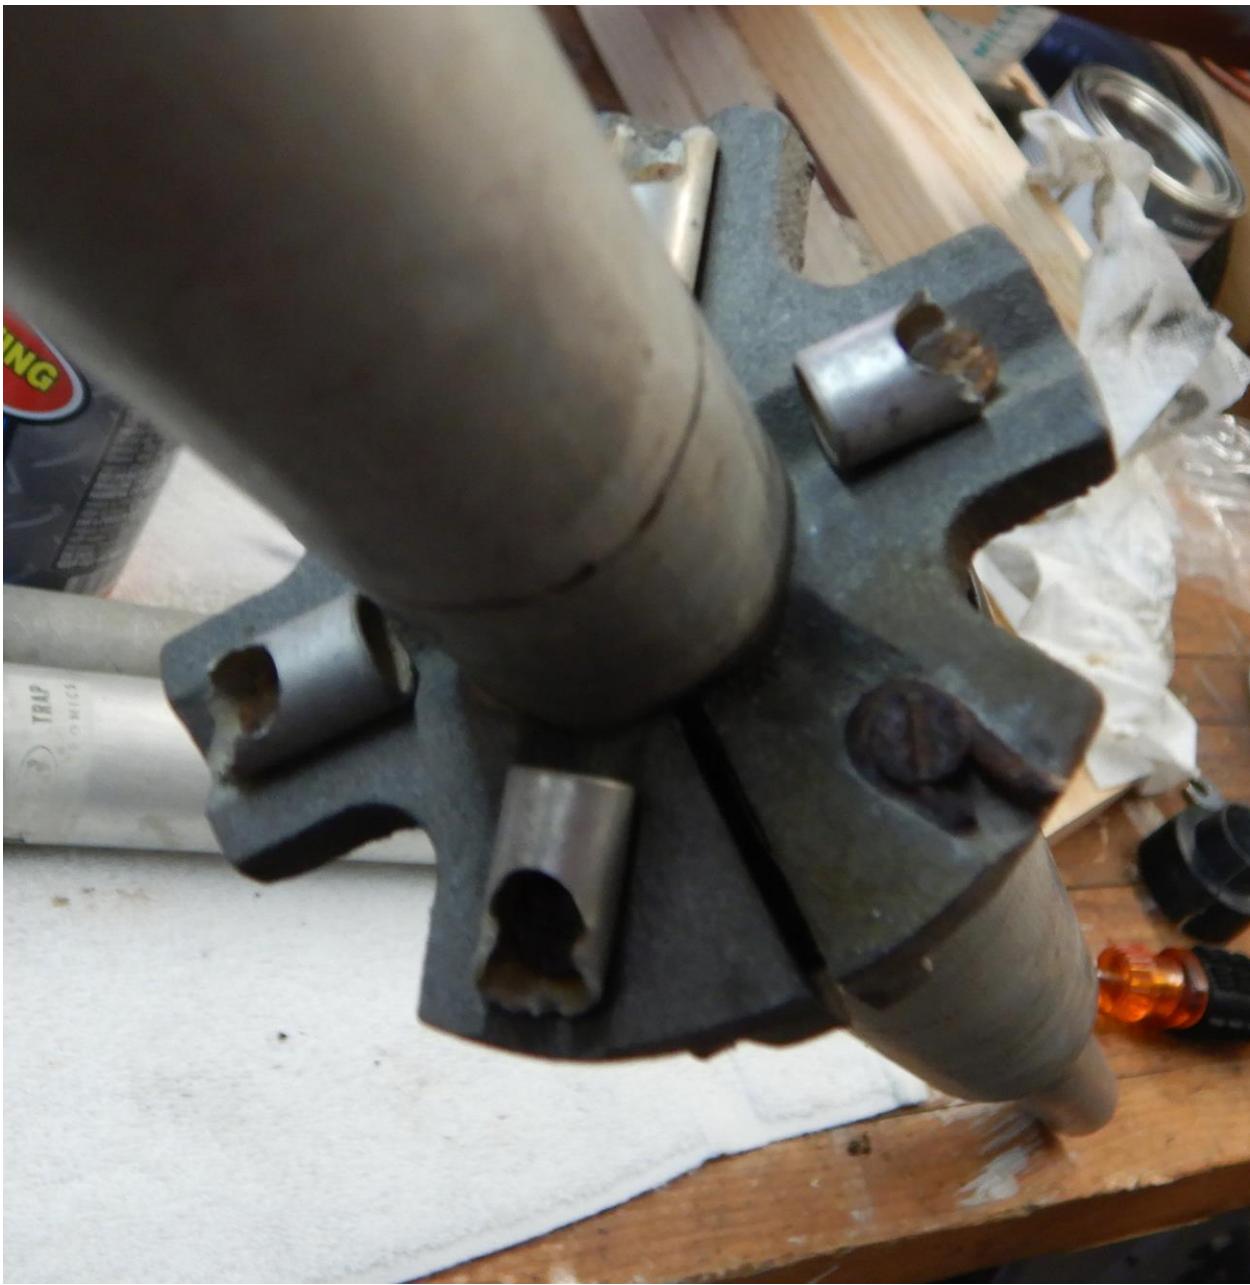
Figure 4: A view of the spider hub. The slots in the screws have all but rusted away!

The Restoration: After doing an assessment of the antenna I ordered a new spider assembly (HSR-9471) and a full set of trap caps (HSR-TRAPCVR-P). I also made a 3/8 x 24 bolt for the top element so I could attach a 75 meter resonator that I happened to have. I also fabricated a three element spider that sits just below the 75 meter resonator this allowed me to turn my 4BTM into a 5BTM. I was able to use the old 6 spoke hub to hold the 3 elements that I made from some scrap aluminum tubing I had left over from another project.

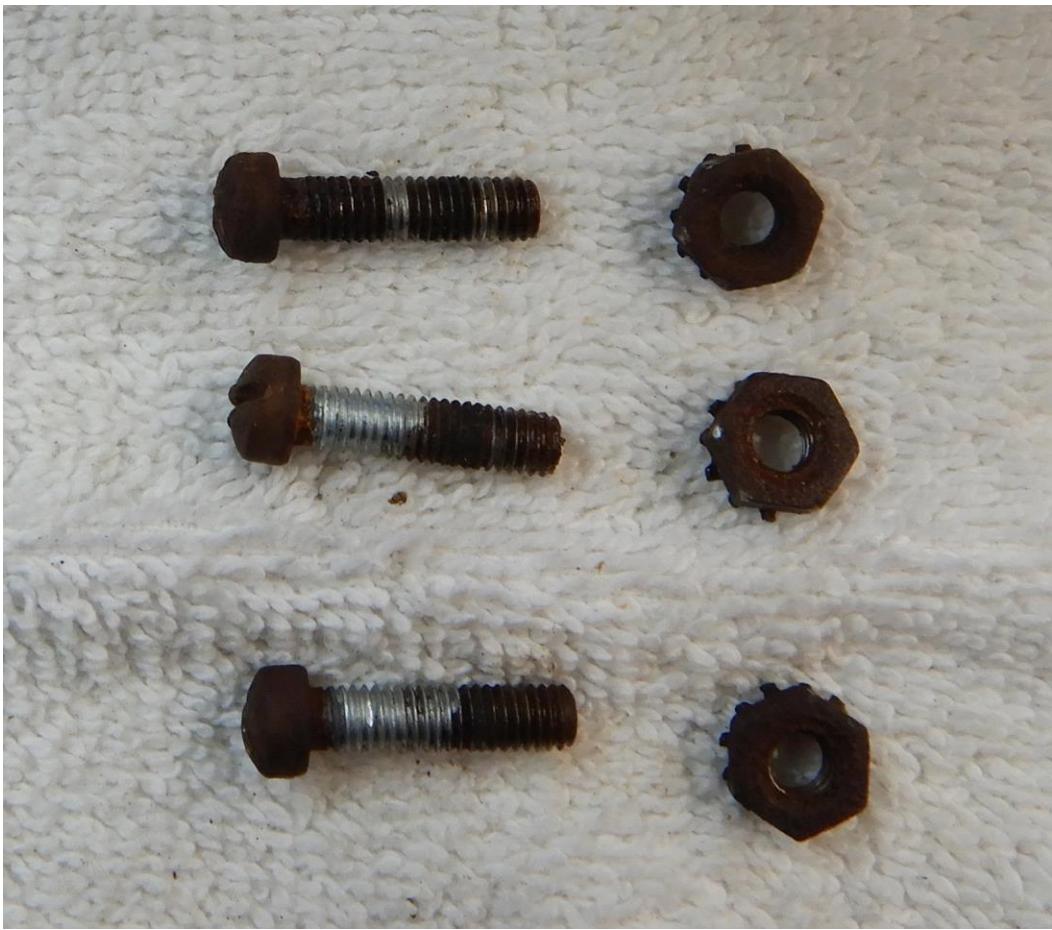
Figure 5: Badly rusted metal fasteners – These aren't the worst ones

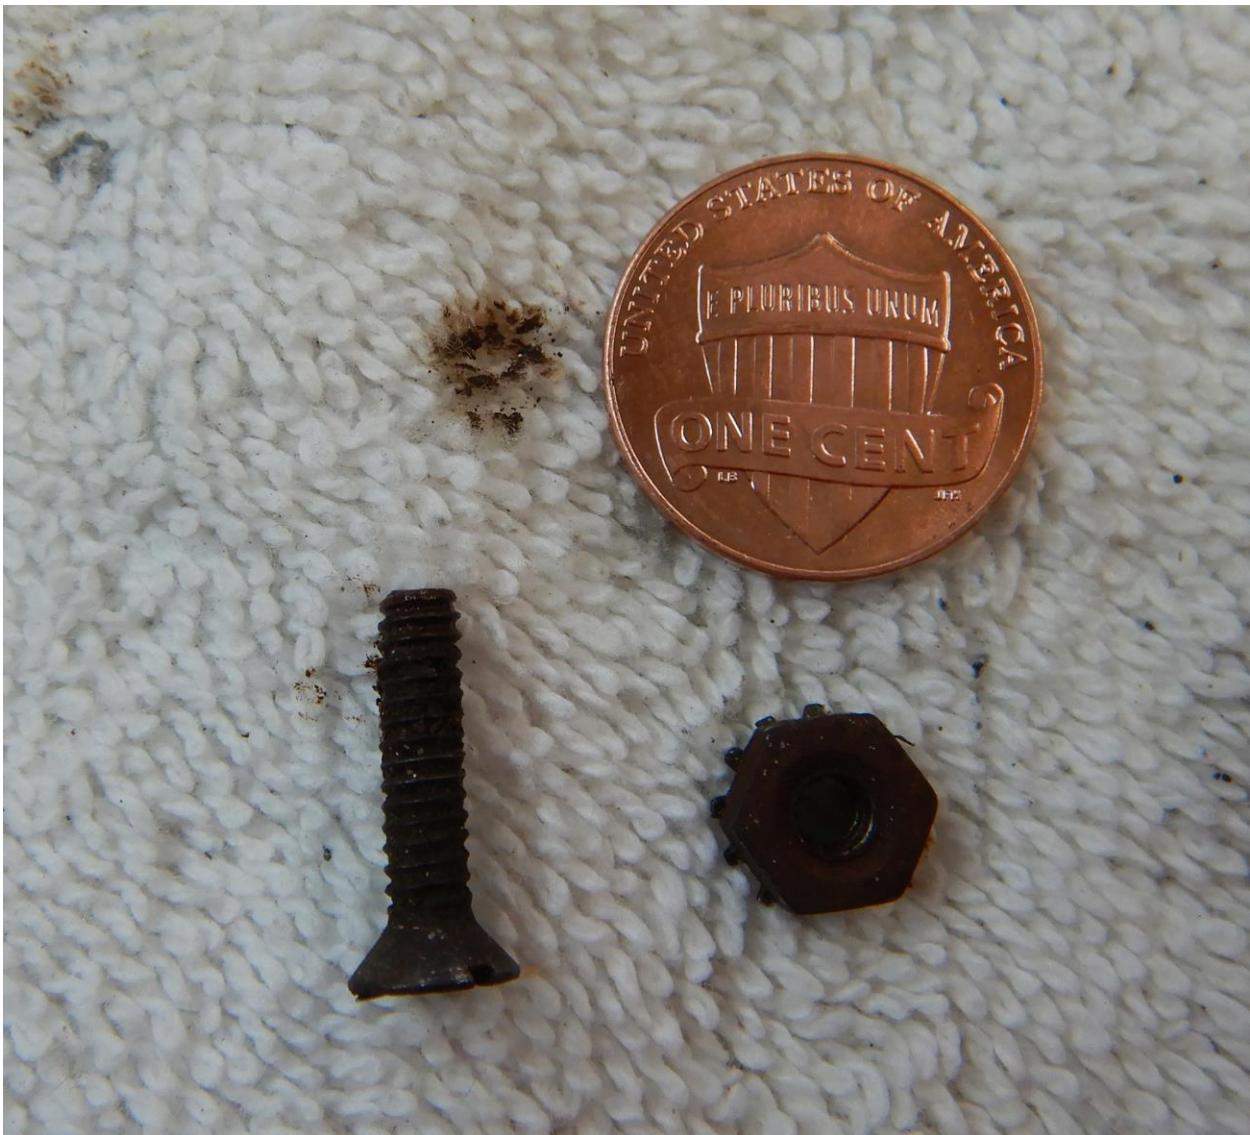
Figure 6: These are the worst examples – This one had enough of a slot left I could unscrew it. The other five screws had to be cut with a chisel

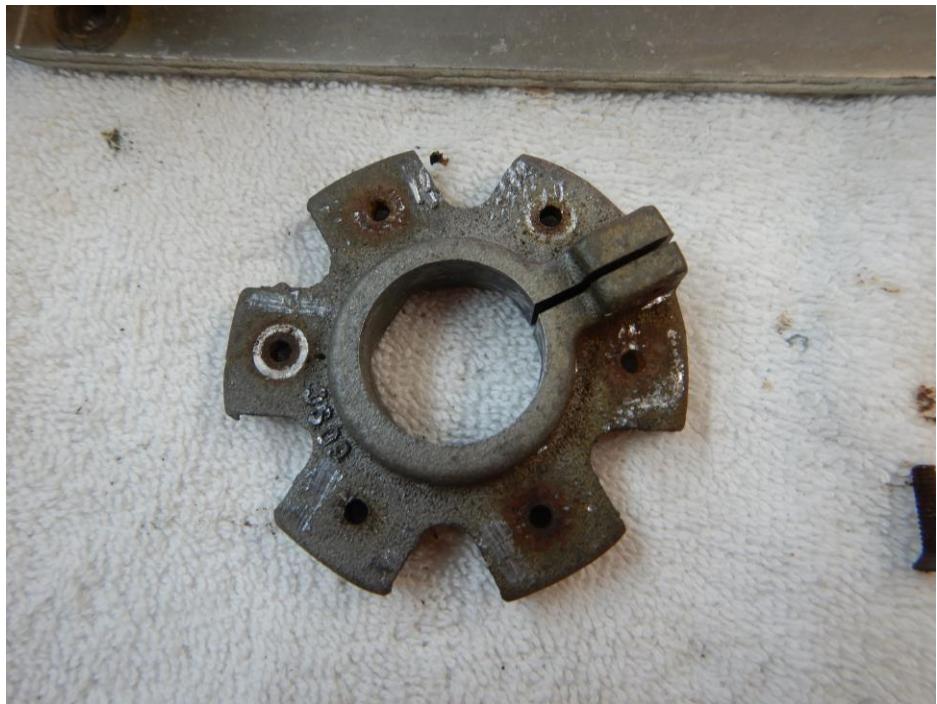
Figure 7: The spider hub before restoration

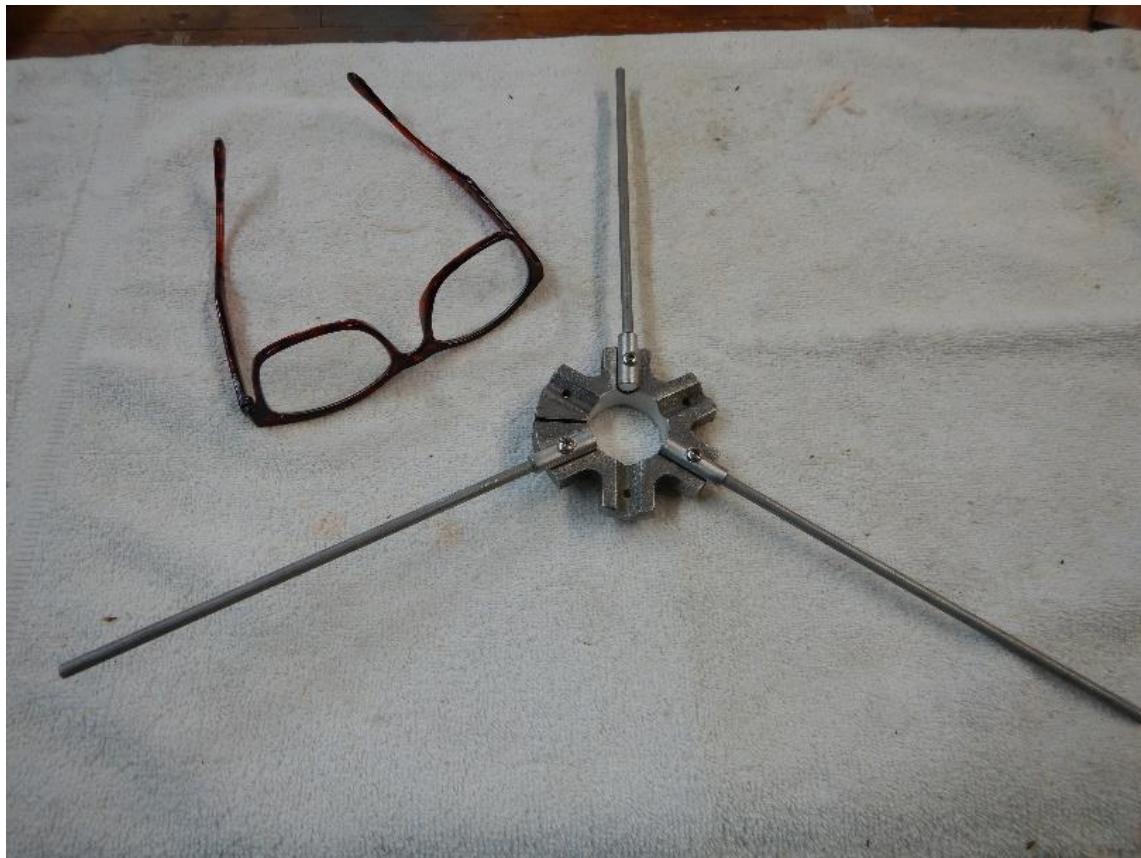
Figure 8: The new spider for 80 meters

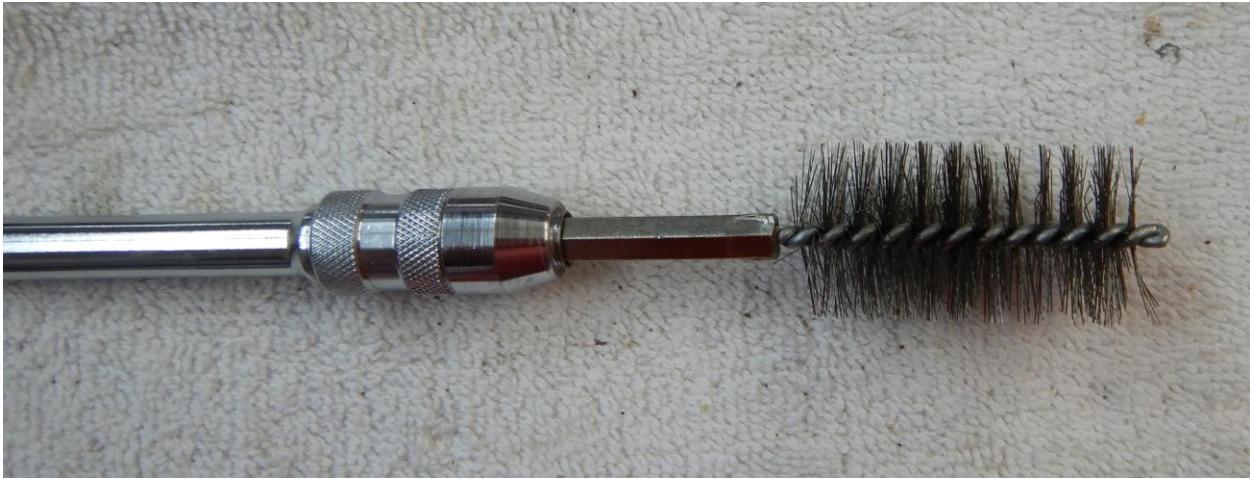
Figure 9: Tubing Cleaner attachment

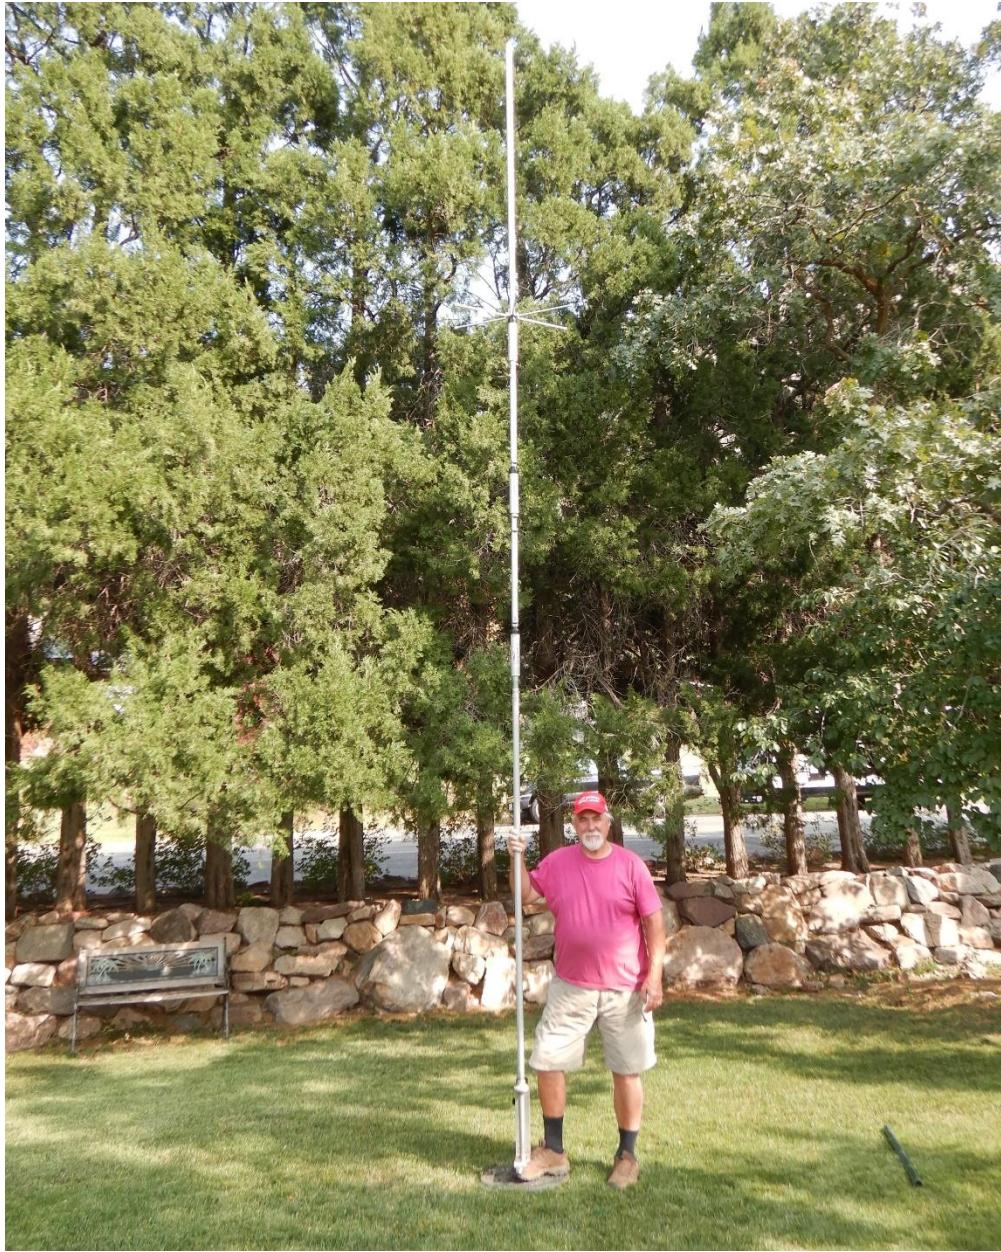
Figure 10: The finished antenna ready to be put back into service.
